**NBSIR 76-1025**

# **Air-Mobility Rigid Shelter Systems**

An Interim Report

Prepared for  
**Air Force Civil Engineering Center**  
**Tyndall Air Force Base, Florida 32401**

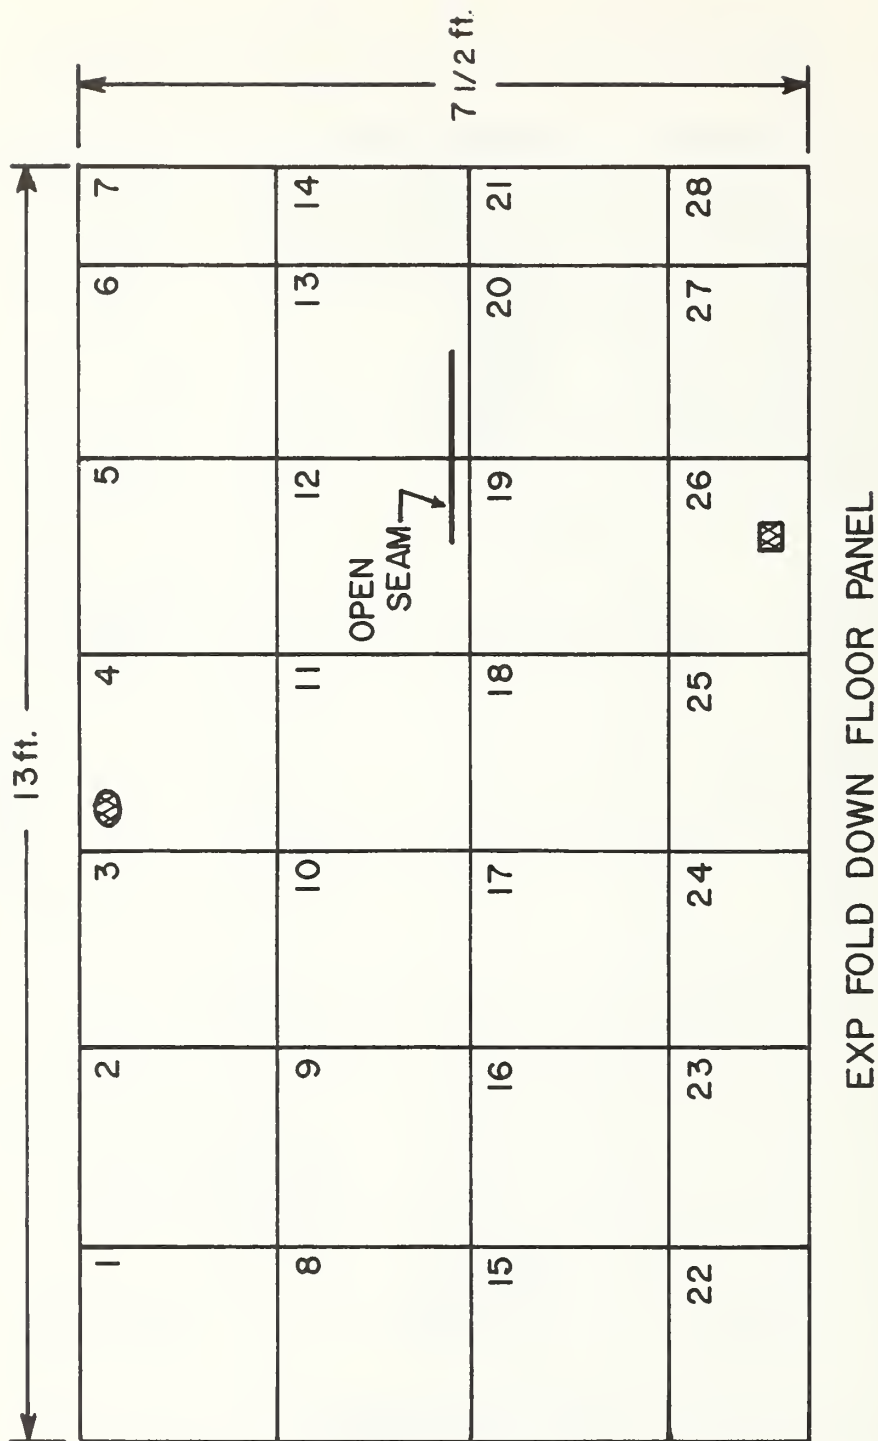
Fig. 3.10 Indentations and damaged areas on exterior of EXP Panel 14 R

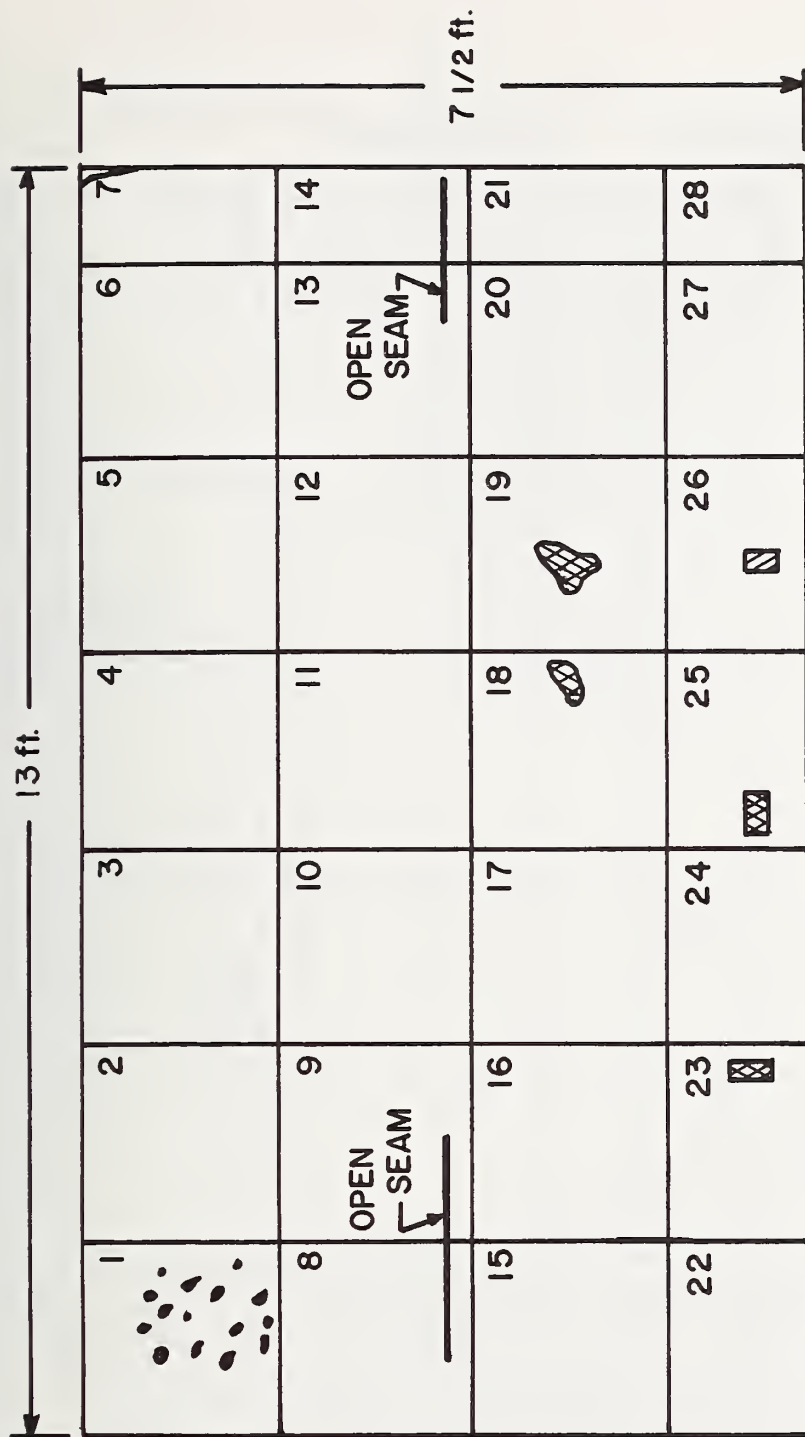
Fig. 3.11 Indentations and damaged areas on exterior of EXP Panel 14 L

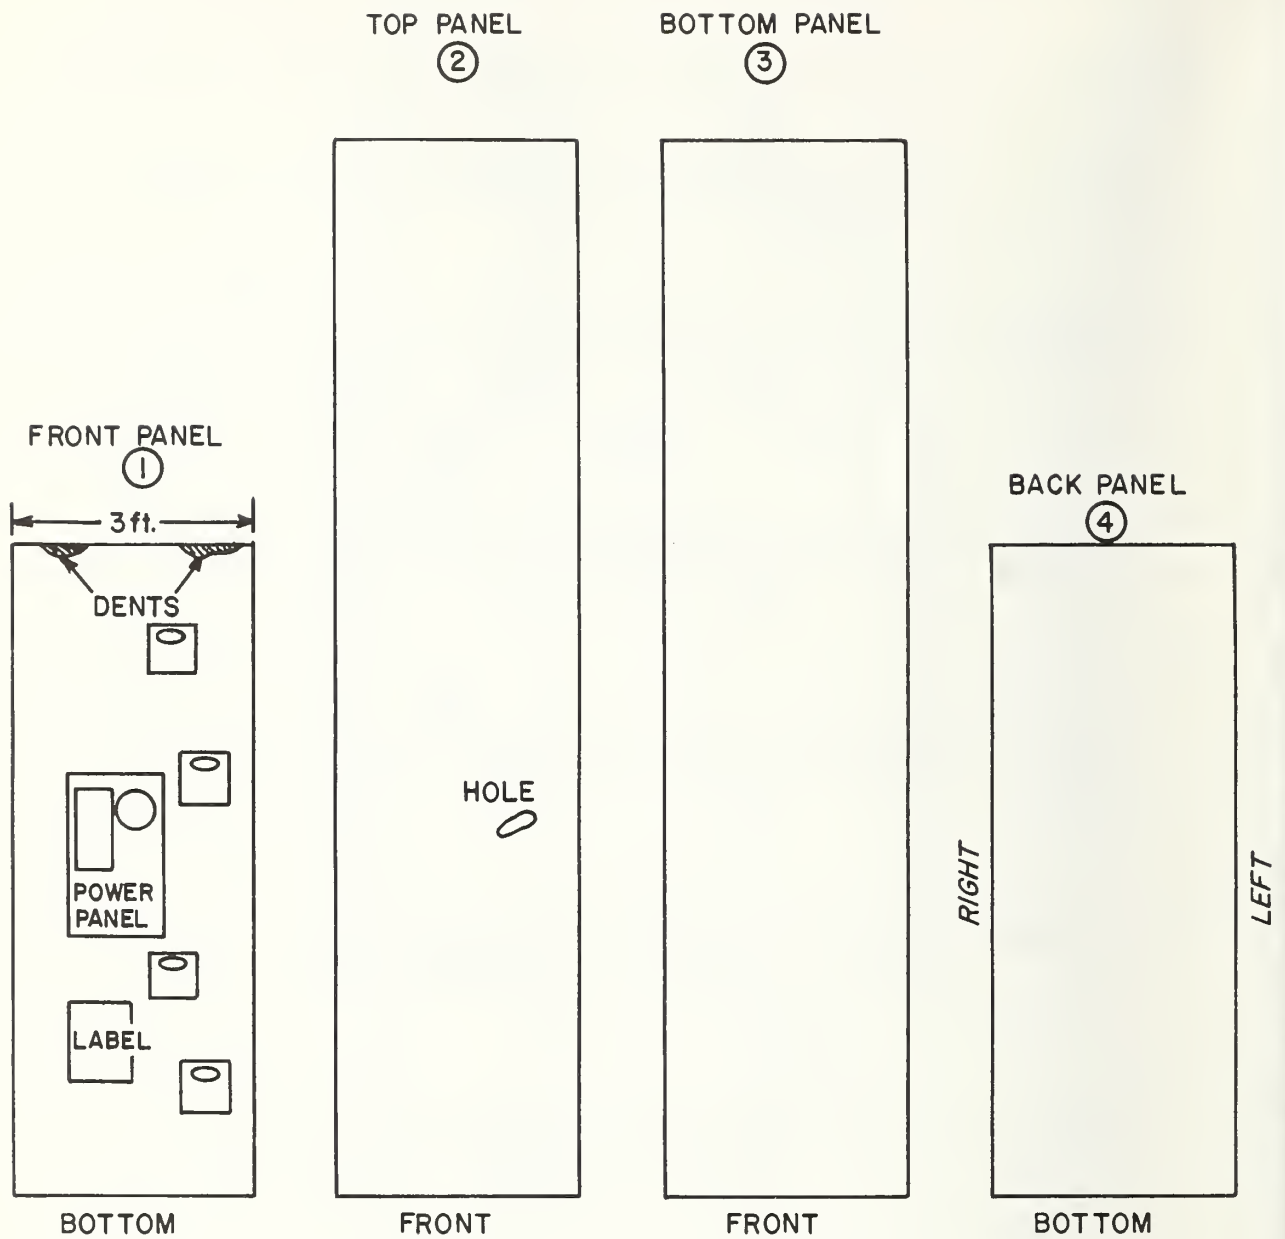
Fig. 3.12 Indentations and damaged areas on exterior of EXP center-structure panels

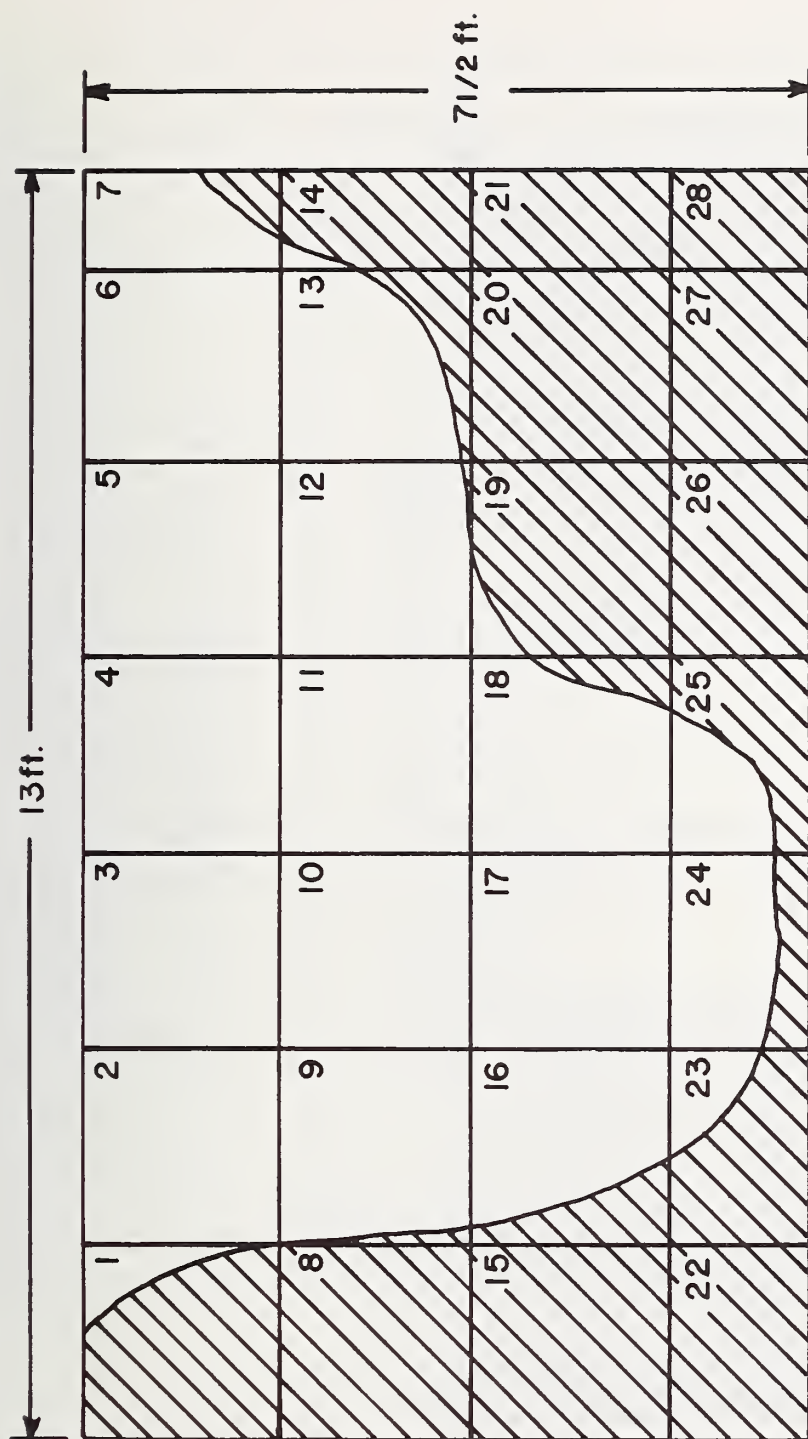
Fig. 3.13 Location of water found in core of EXP Panel 14 R

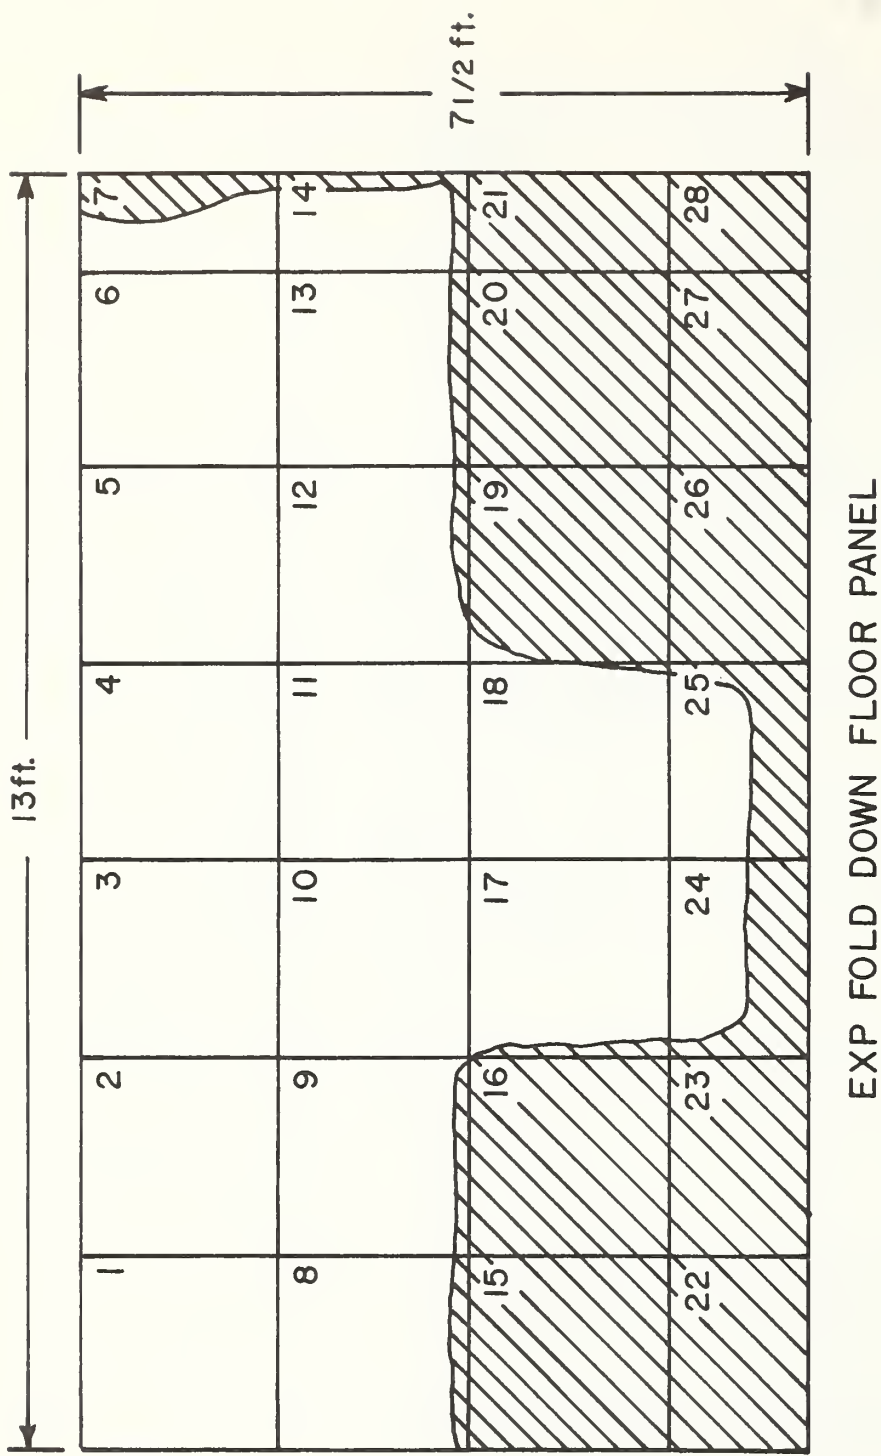
Fig. 3.14 Location of water found in core of EXP Panel 14 L

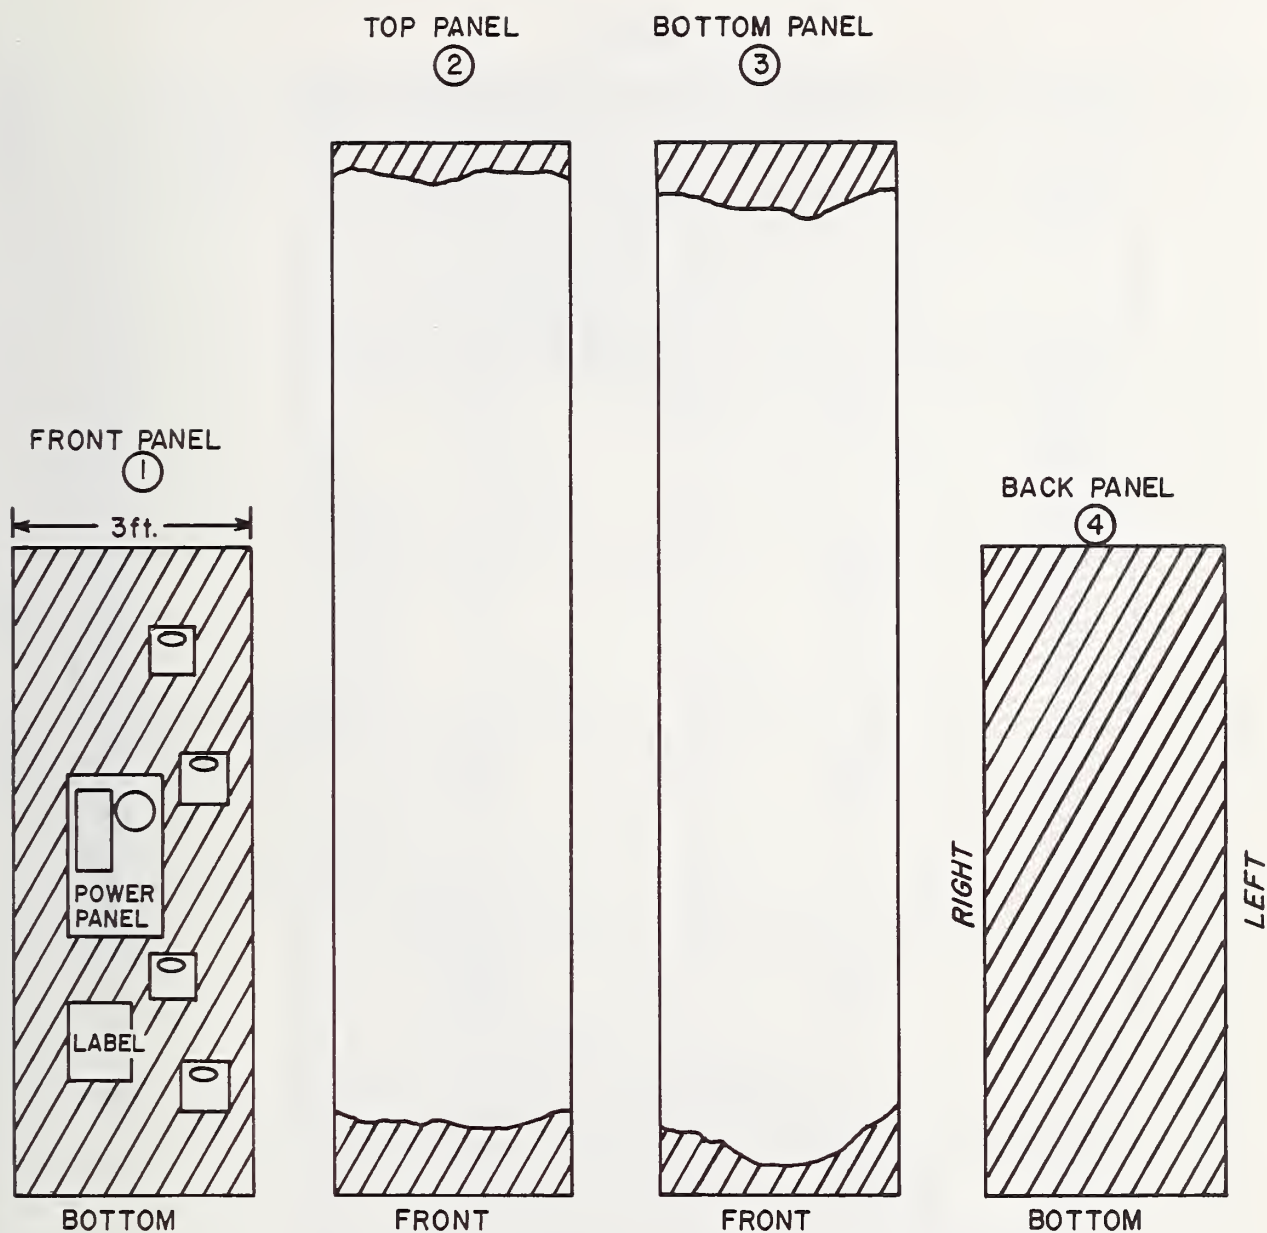
Fig. 3.15 Location of water found in core of EXP center-structure panels

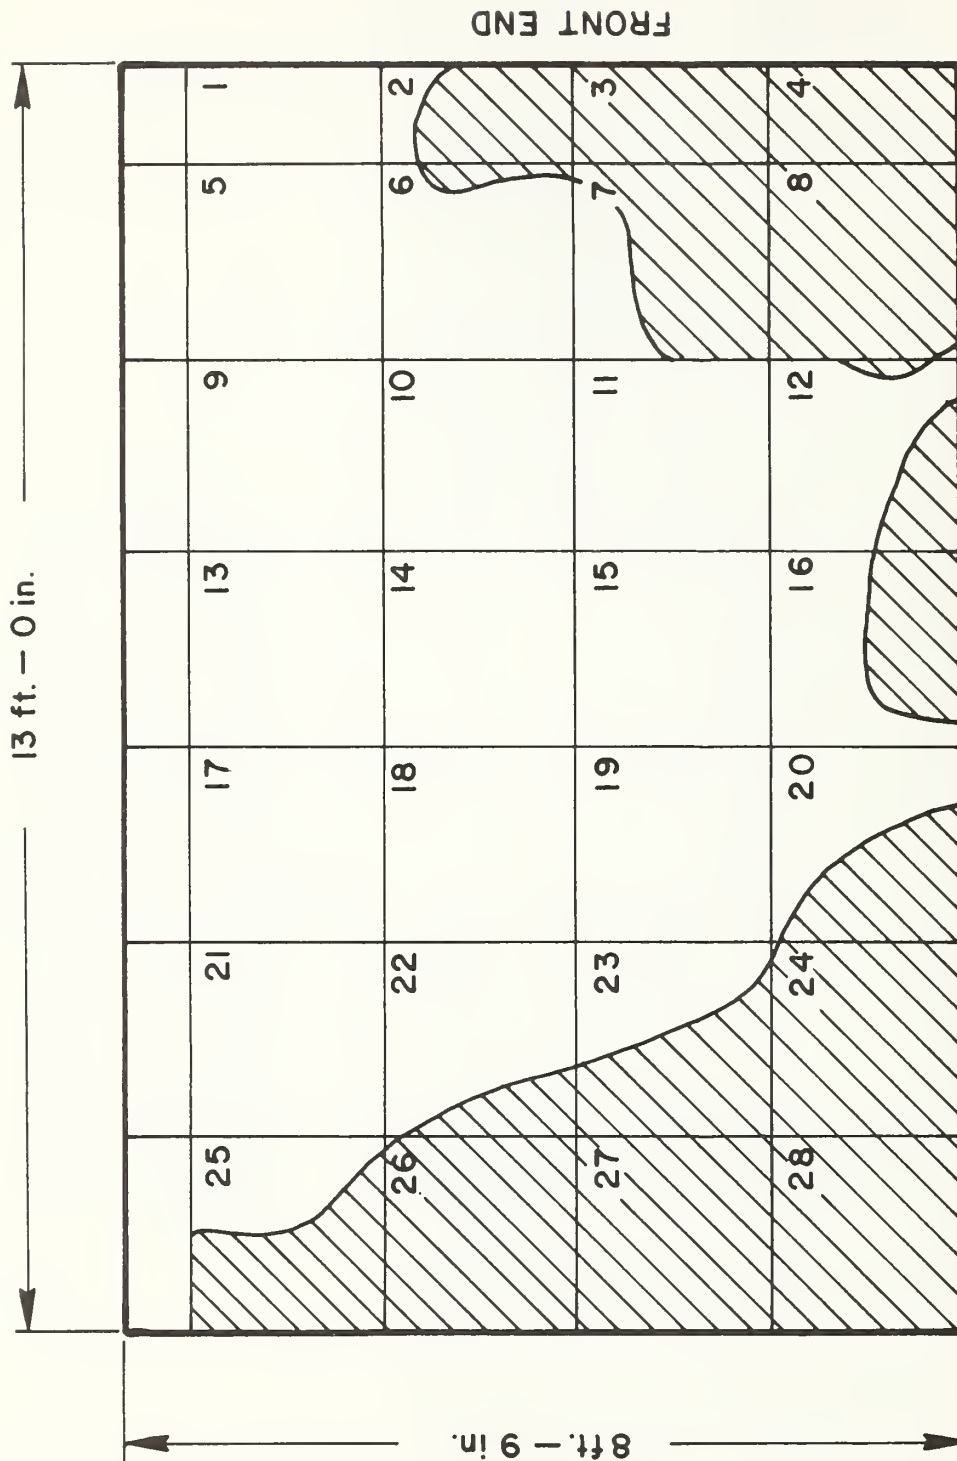
Fig. 3.16 Delaminations of interior facing on  
ES/C Panel 3 (Fixed floor panel)

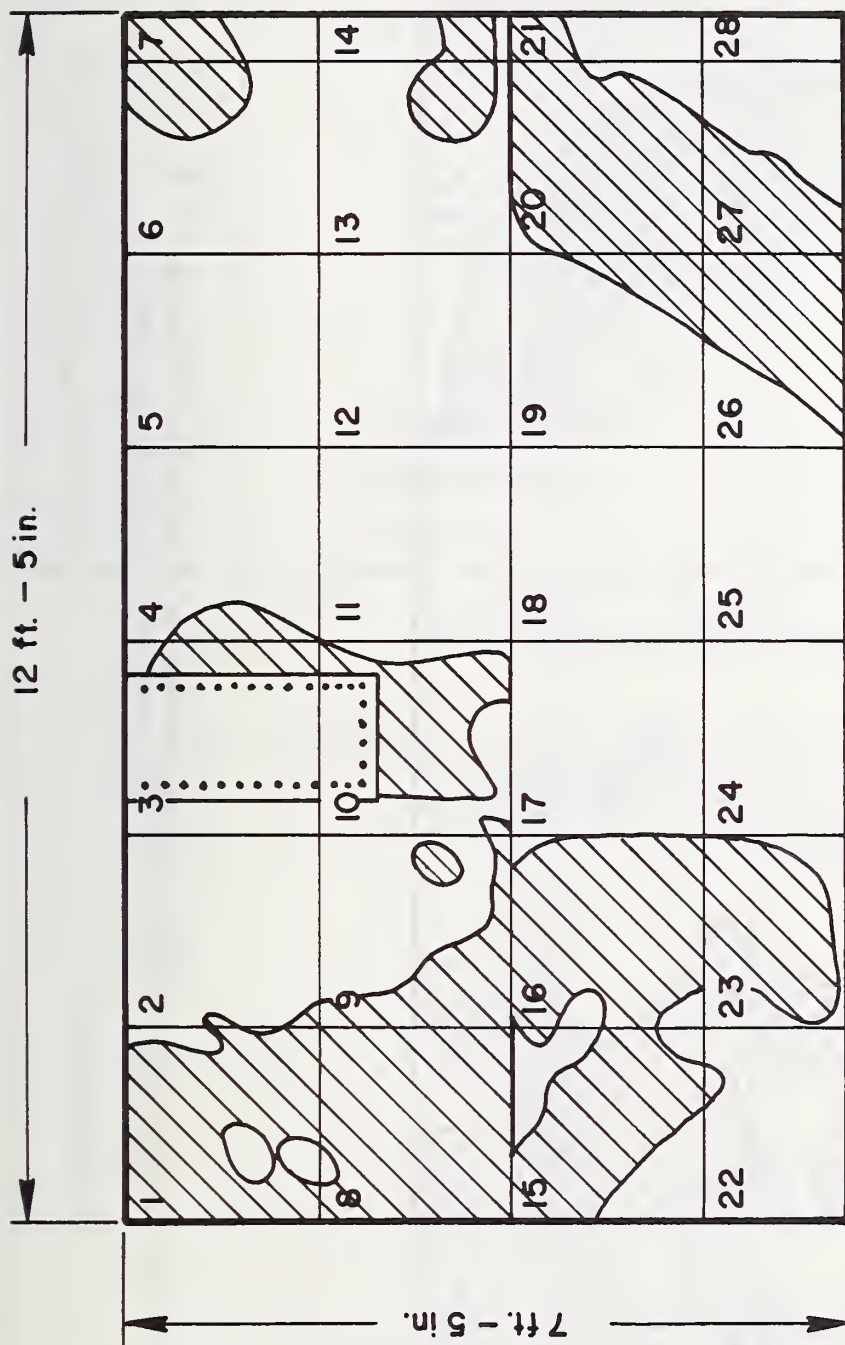
Fig. 3.17 Delaminations of exterior facing on ES/C Panel 5 R (Fold-down floor panel)

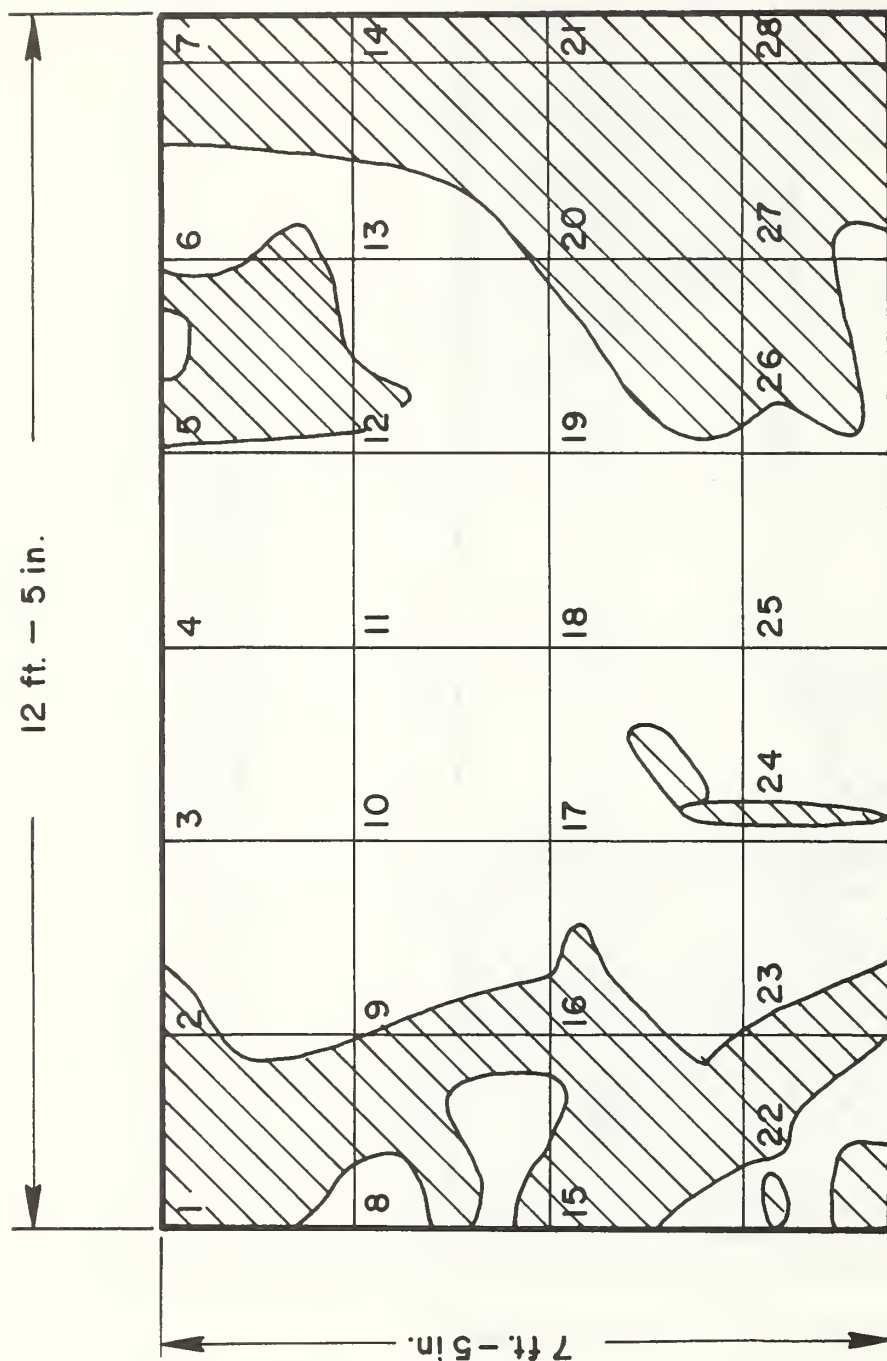
Fig. 3.18 Delaminations of exterior facing on  
ES/C Panel 6 L (Fold-up roof panel)

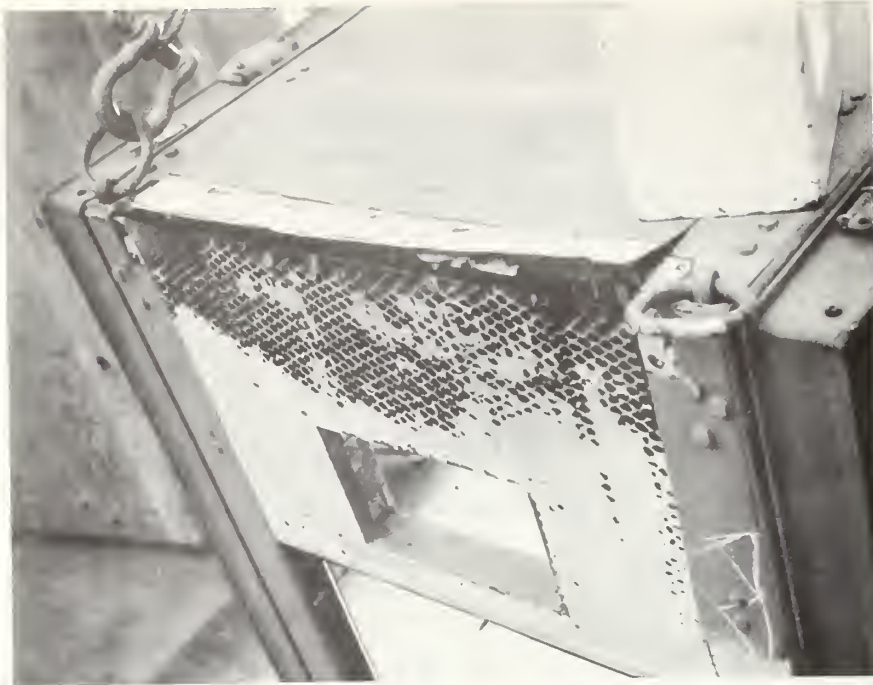
Fig. 3.22 Water-entry point on upper corner of EXP center structure (Aluminum corner seal removed)

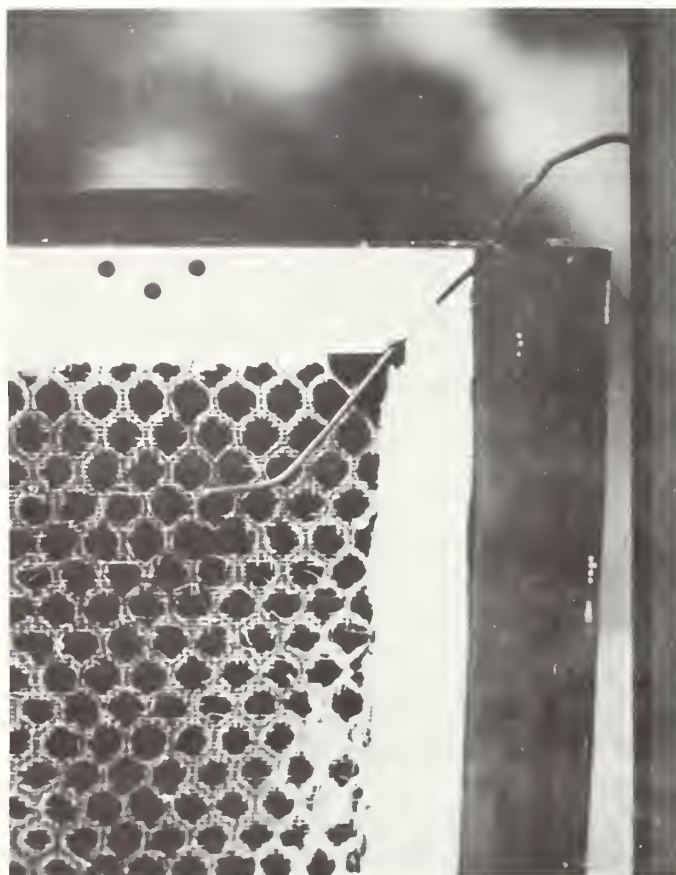
Fig. 3.23 Water entry point on upper corner of EXP Panel 14 L (Fold-down floor panel)
